## Recording of a lift gate adjacent to Bridge 106, Gilwern, Monmouth and Brecon Canal

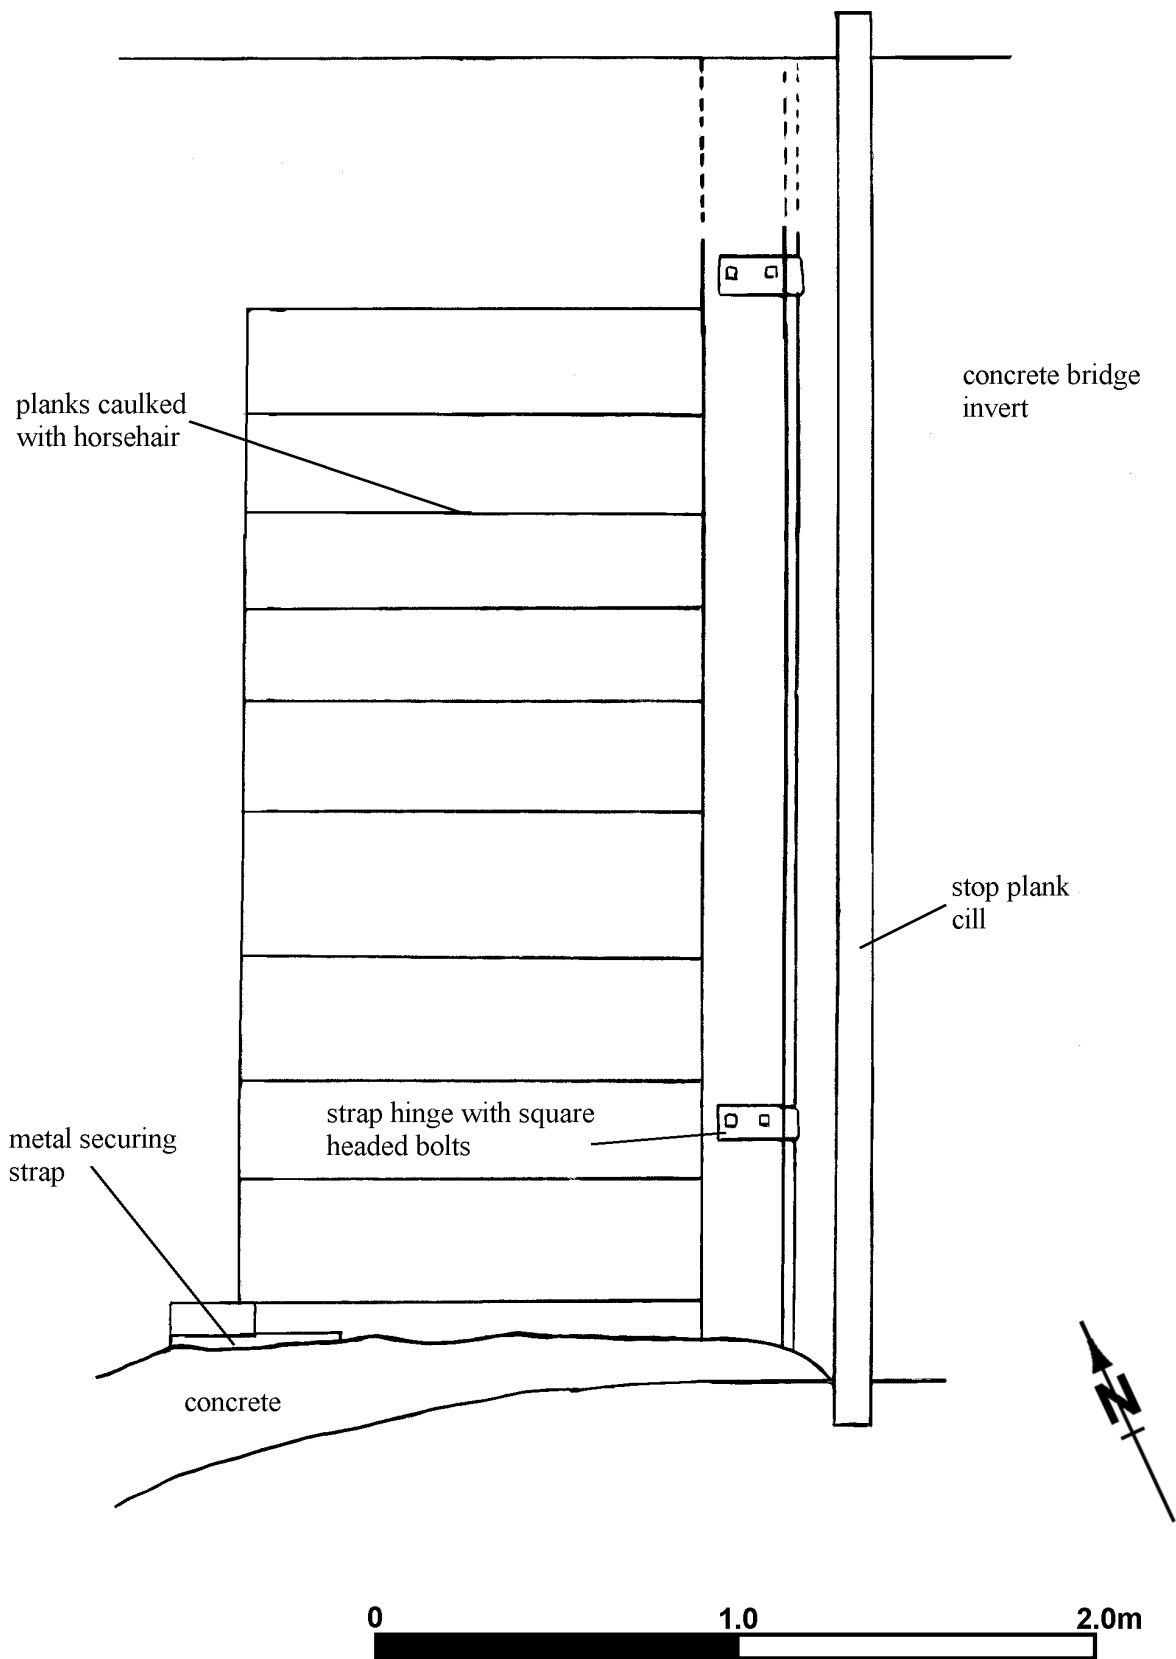
Fig 2: Plan of lift gate at Gilwern

The lift gate originally comprised a rectangular timber frame (Figs 2 and 5). Of the frame timbers, only the timber forming the pivot at the base of the gate could be satisfactorily measured. This was 0.25 to 0.3m square. It is thought that, in order to obtain a satisfactory joint with this timber, the side timbers must have been of comparable scantling. The top frame timber was missing. The planks were set into a channel cut in the length of the basal timber and it is clear from the remains of a joint (Fig 7) that they were set into a comparable channel in the top timber also. The planks were about 25mm thick and varied in width but, on the whole, were about 0.3m wide. The planks were caulked with a fibrous substance thought to be horsehair.

Two hinges were positioned near either end of the basal timber. A small recess had been cut in the timber cill against which the gate would have closed to accommodate the hinges (Figs 2 and 6). Each hinge was secured with two bolts, or possibly screws, with square heads. A metal strap, approximately 0.3m long, was placed over the join between the side timber and the top timber (Figs 2 and 7).

A visit was paid to the Waterways Trust archive at Gloucester for any documentary evidence relating to lift gates on the Monmouth and Brecon Canal. No direct mention was found of lift gates. Stop gates were referred to (BW 92/8) but it is believed that these references relate to vertically hinged swing gates such as the one seen adjacent to the lift gate recorded by this project (Fig 4). The lack of references implies that lift gates were an early, presumably original feature. The last time that the lift gate was seen was probably subsequent to an engineering survey carried out in 1963 (BW 133/054 Comprehensive Engineering Survey Report; Flyndneron (*sic*) Bridge 106). This identified that the wing walls of the bridge hole needed rebuilding. This work was probably undertaken and resulted in a quantity of concrete being placed beneath and in front of the wing walls. This may be seen overlying one of the side timbers (Figs 2 and 5).

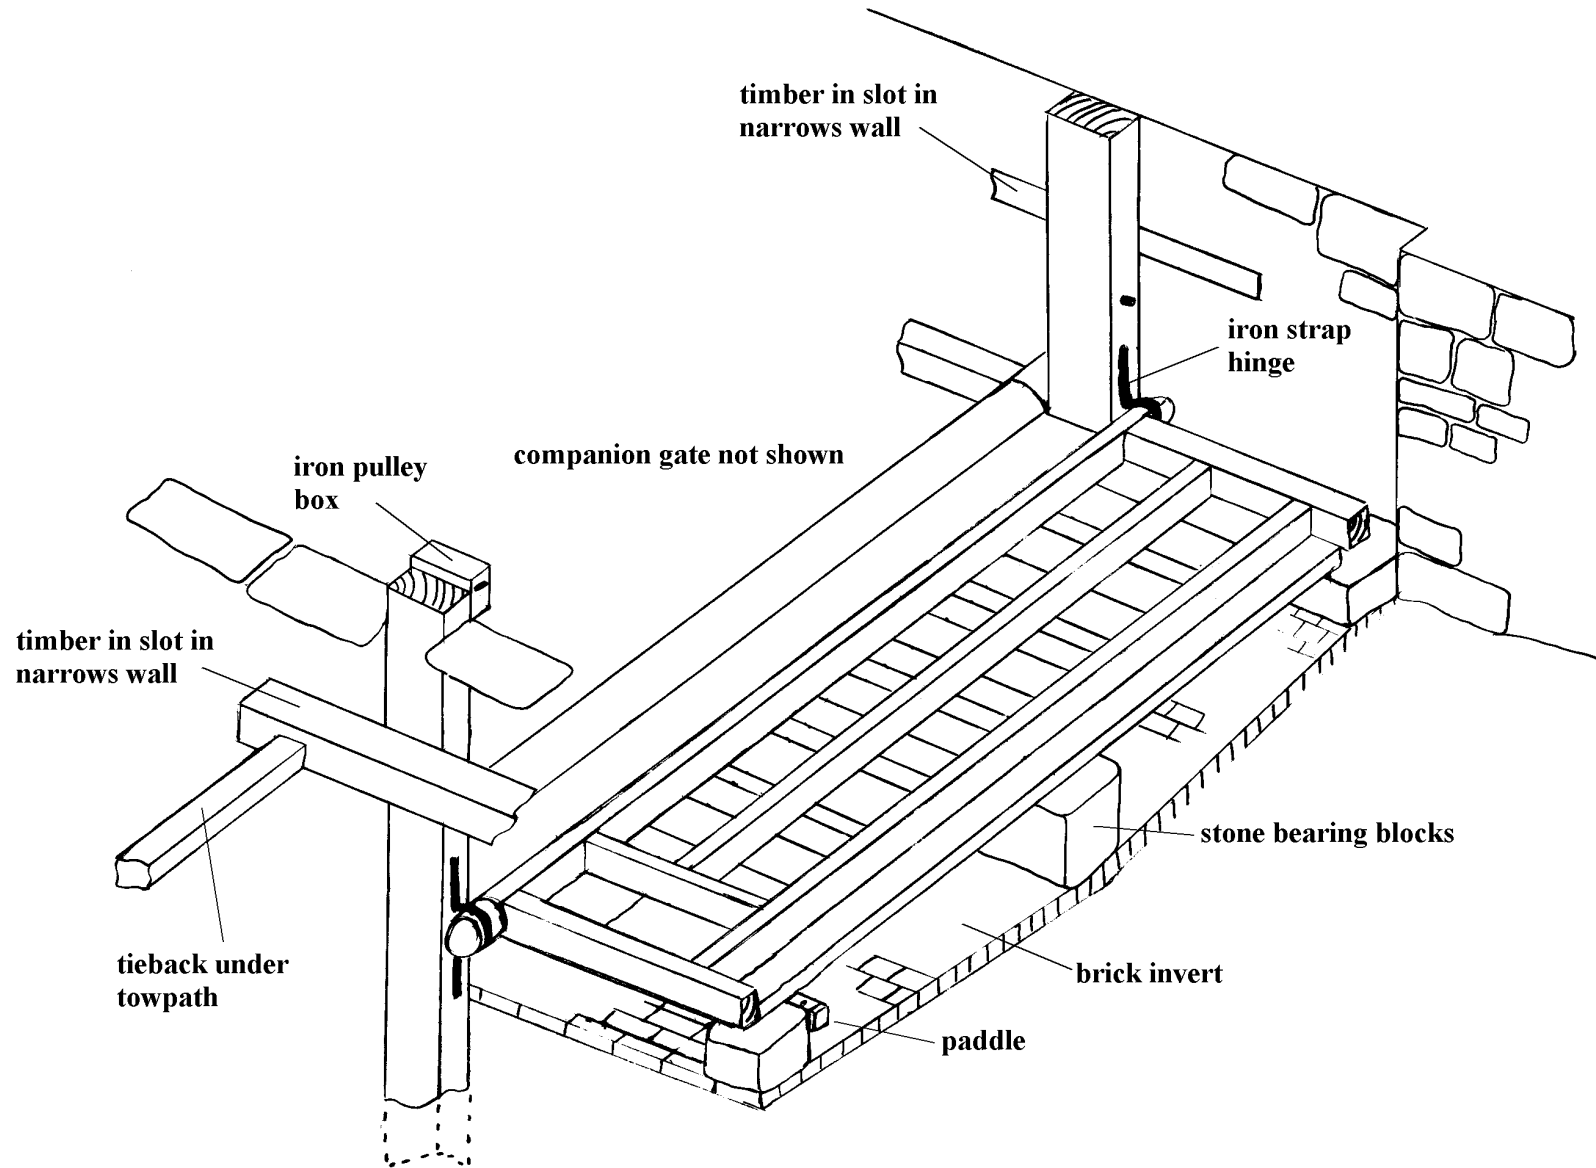
Fig 3: Lift gate at Winsley Hill, Kennet and Avon Canal

A lift gate was recorded at Winsley Hill on the Kennet and Avon Canal (K&A) in 2000 by the author (Coxah and Gardner 2000; Fig 3). The recorded gate formed one of a back-to-back pair and lay within its own narrows. It seems that the idea was that a breach on either side of the gate would result in the gate on the upstream side rising and preventing too great a loss of water. A cast iron pulley box was provided on the towpath side. This could have enabled the emergency gates to be used for planned maintenance also: either of the gates could be raised by hitching a horse, with a chain and/or rope, through the pulley box to the gate, and pulling it up. This process would have been made easier for the horse by opening a paddle built into the gate, which would have been closed before de-watering the downstream section of the canal. To subsequently re-water the de-watered section, the paddle would again have been raised until the water level had equalised on both sides of the gate. The gate could then be lowered and the re-watering completed.

The gate at Gilwern was similar in many respects to the example on the Kennet and Avon Canal (Fig 3). There were, however, a number of significant differences. The example on the K&A had a longitudinal mid brace, terminating adjacent to a paddle mechanism. The example at Gilwern had neither. On the K&A the boards were secured to the face of the frame timbers; at Gilwern they were set into a longitudinal channel cut in the top and bottom timbers. On the K&A the gate lay on stone bearing blocks, themselves set onto a concave brick apron. This would have facilitated the automatic lifting of the gate when water flowed over it at a sufficient

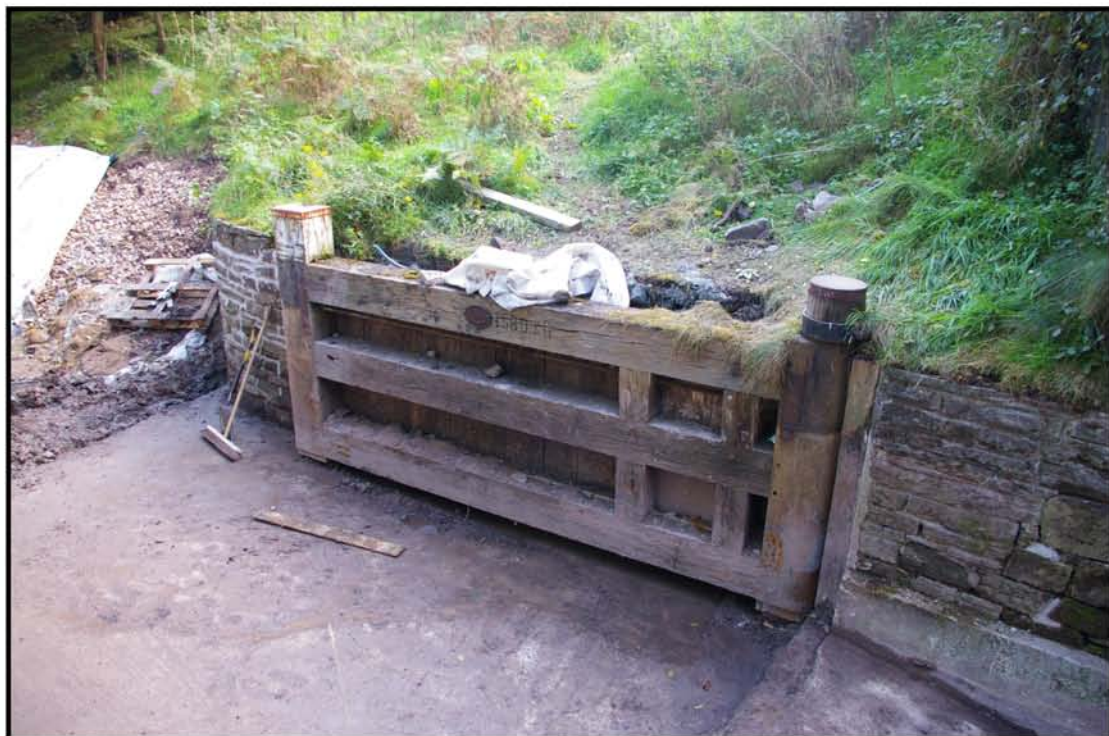
Fig 4: Swing gate in eastern forebay

The lift gate lay in the western forebay of a bridge hole (Bridge 106 - Ffynnon-Eirin Bridge; Fig 1) on the side of the valley of the river Usk. In the eastern forebay was a swing gate, pivoted on the offside of the canal (Fig 4).

On the K&A the recorded gate was one of a pair, positioned back to back, in its own narrows. At Gilwern there may have been a companion lift gate in the position now occupied by a much more common swing gate (Fig 4). There is no evidence one way or the other. The Gilwern gate also occupies the fore bay of a bridge hole, rather than having its own narrows. It is unknown if the Gilwern gate had a pulley box similar to the example on the K&A although such pulleys are known elsewhere on the Monmouth and Brecon Canal.

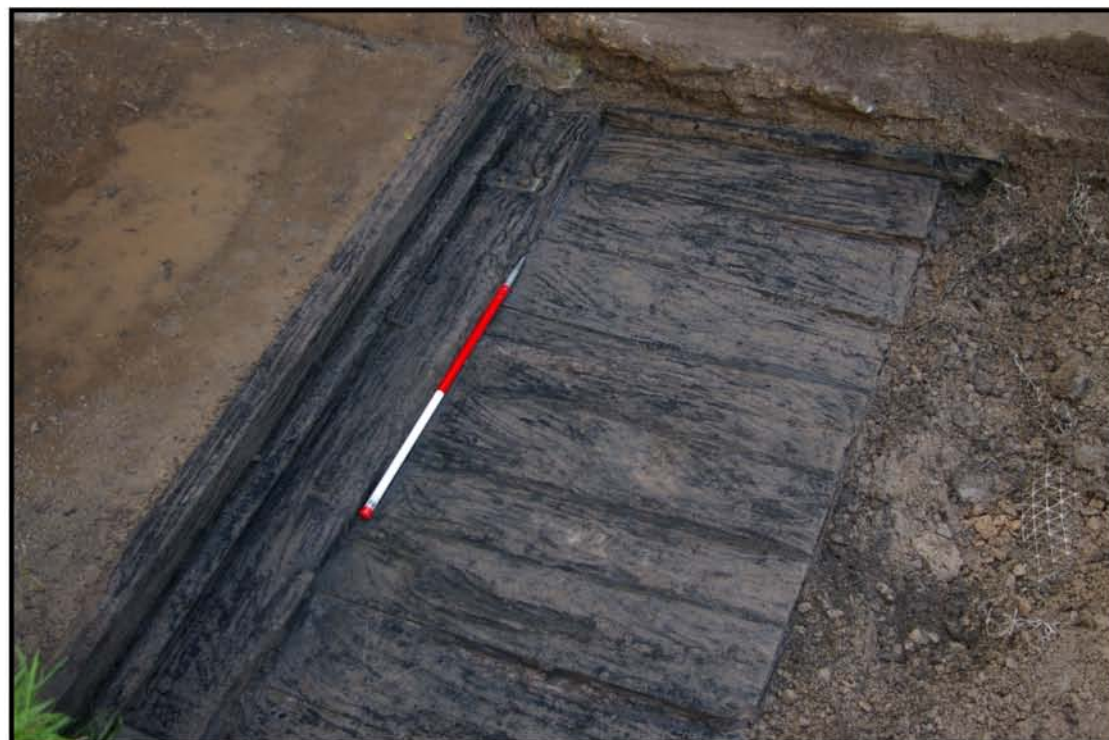
Fig 5: Lift gate in western forebay

The gate has lost one of its side and one of its longitudinal frame timbers (the upper timber) and is therefore in a fragile condition with its planks being secured only in a single slot in the basal timber. Its apron appears to have subsided in a couple of places, allowing the timbers to collapse into the hollows thus formed.

Preservation *in situ* is the only realistic way that the lift gate can be preserved. It is possible to preserve water-logged timbers once they have been removed from their original environment but it is a time-consuming and very expensive process. Therefore, preservation *in situ* provides the best chance for the physical survival of the lift gate.

On balance it is believed that, so long as the cost of modifying the various construction details in the vicinity of the lift gate is modest, preservation *in situ* is the best solution. If funds can be found it is recommended that an interpretation panel featuring a reconstruction of the gate should be mounted in the vicinity of the site. An illustrator, who in the author's experience has unrivalled experience in the preparation of such panels, including the supply of suitable lecterns on which to mount them, is given in Appendix 1.
