**Watching brief
at land at
Blakesley Hall School
Yardley Green Road
Stetchford**

SMR 20628

Martin Cook BA MIFA

20th November 2008
Revised 4th December 2008

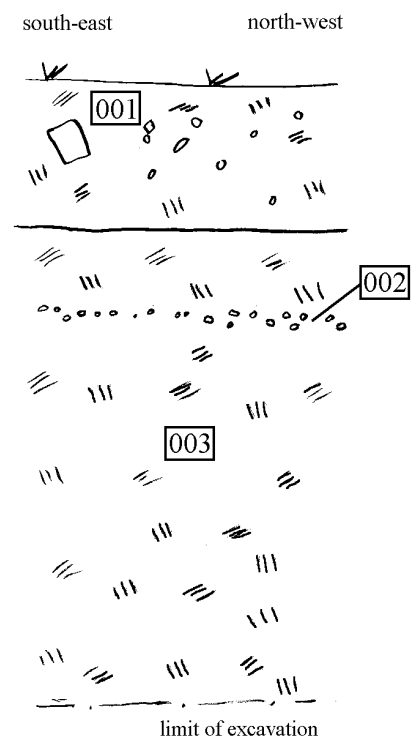
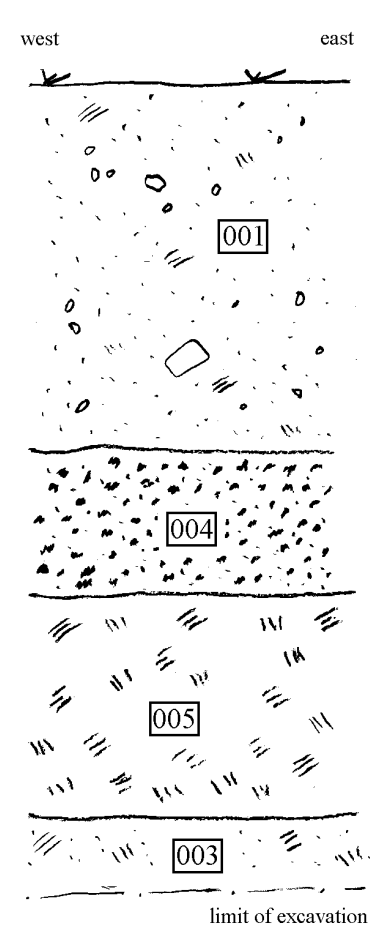
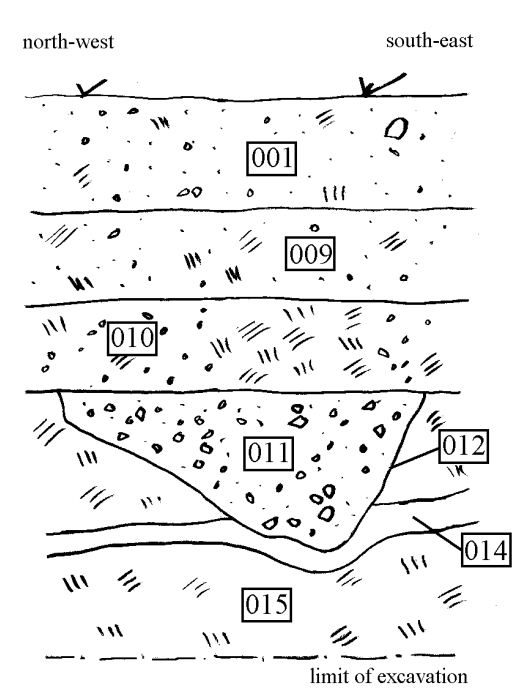
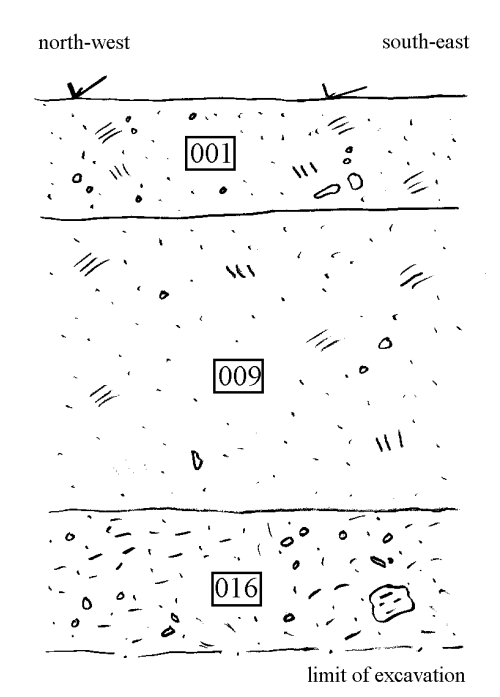
Fig 3: Sections 1 to 4

In the vicinity of the brick kiln the sections of two of the pile caps were recorded (Figs 2 and 3; sections 3 and 4). Ground reduction was significantly less here, the depth of excavation being around 1.6m beneath existing ground level. Here, beneath topsoil (context 001) and other layers associated with the ceasing of landfill and school construction (contexts 009 and 010) were substantial layers of landfill including a similar slaggy material to that identified in context 004 and abundant pottery fragments (context 016). The pottery has been dated to the 19th century (see below). Some reworking of the landfill material had clearly taken place as a large posthole or small pit (context 012) had been excavated into the landfill and filled with another variation on the slaggy material described above (context 011).

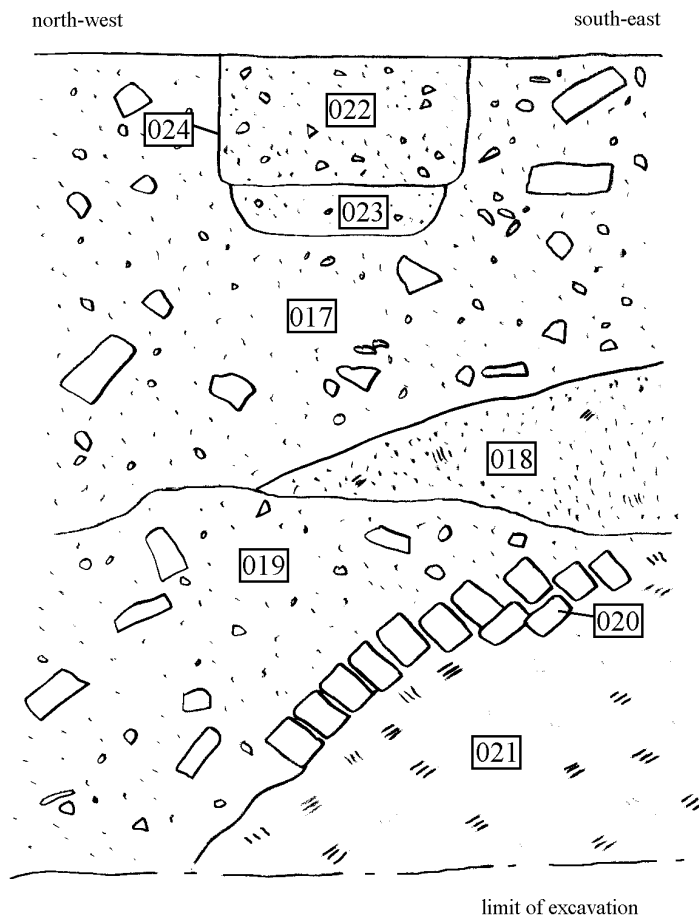
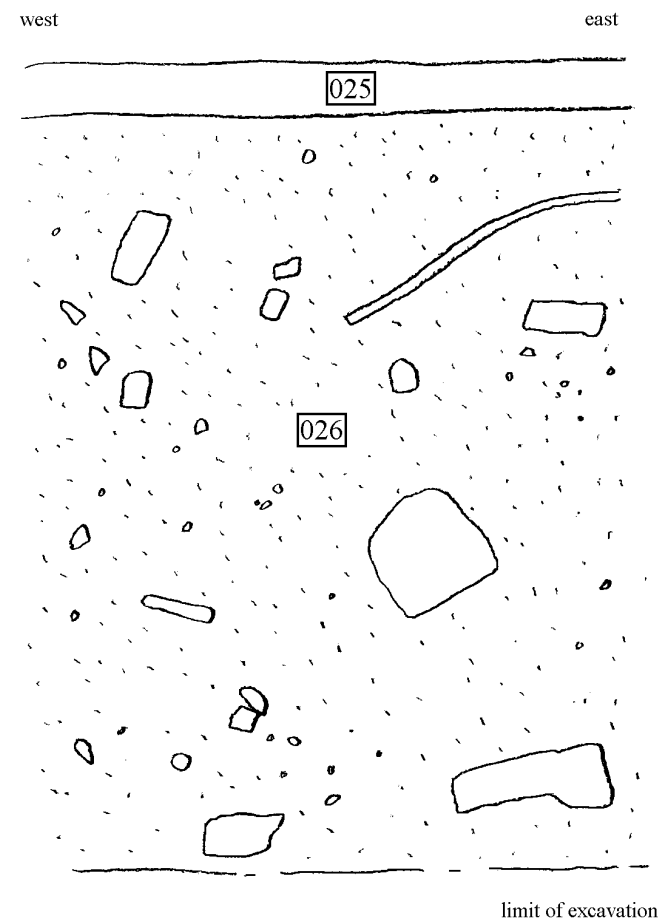
Fig 4: Sections 5 and 6

In this area two deep service trenches, the bases of which were approximately 4 or 5m beneath existing ground level, were subsequently excavated to the south-west and south-east of the brick kiln, at a distance of approximately 35m and, in the case of the latter, immediately adjacent to or immediately over it. (Figs 2, 4; (section 5) and 9). These were excavated through the remains of the landfill recorded elsewhere (to a depth of *c* 0.4m; context 004) and the Mercian Mudstone (context 003). The part of the trench that passed immediately adjacent to the anticipated position of the brick kiln (Fig 2) was not sufficiently deep to reach it, the bottom of the trench still being in landfill deposits. However, an interesting deposit was recorded in section 5 (Fig 4). This was an alignment of bricks (context 020), lying upon the natural subsoil which, at this point, was a grey clay (context 021). These bricks had the superficial appearance of an arch. They were not, however, mortared together and it soon became clear that they did not, and had not, formed part of any structure. Their disposition was, however, peculiar. No entirely satisfactory explanation can be offered but the following is proposed. Since they lay upon the natural subsoil, rather than within a landfill deposit, it is possible that they are one of the final products of the brick kiln; perhaps a few tens or scores of bricks that were never taken off site. Their deposition might be accounted for by the antics of children playing in the abandoned brickworks (ie piling up bricks and knocking them over). A sample of one of these bricks, which were all identical was taken (brick 5; see below).

In the far south-east of the site a final service trench was excavated (Figs 2 and 4; section 6). This passed through landfill deposits only.

Aims 1) and 2) of the watching brief could not be fulfilled as the brick kiln was not encountered in any of the excavations. Aim 3), to identify the size and fabric of bricks produced on the site may have been fulfilled if the explanation for the bricks in section 5 is accepted.

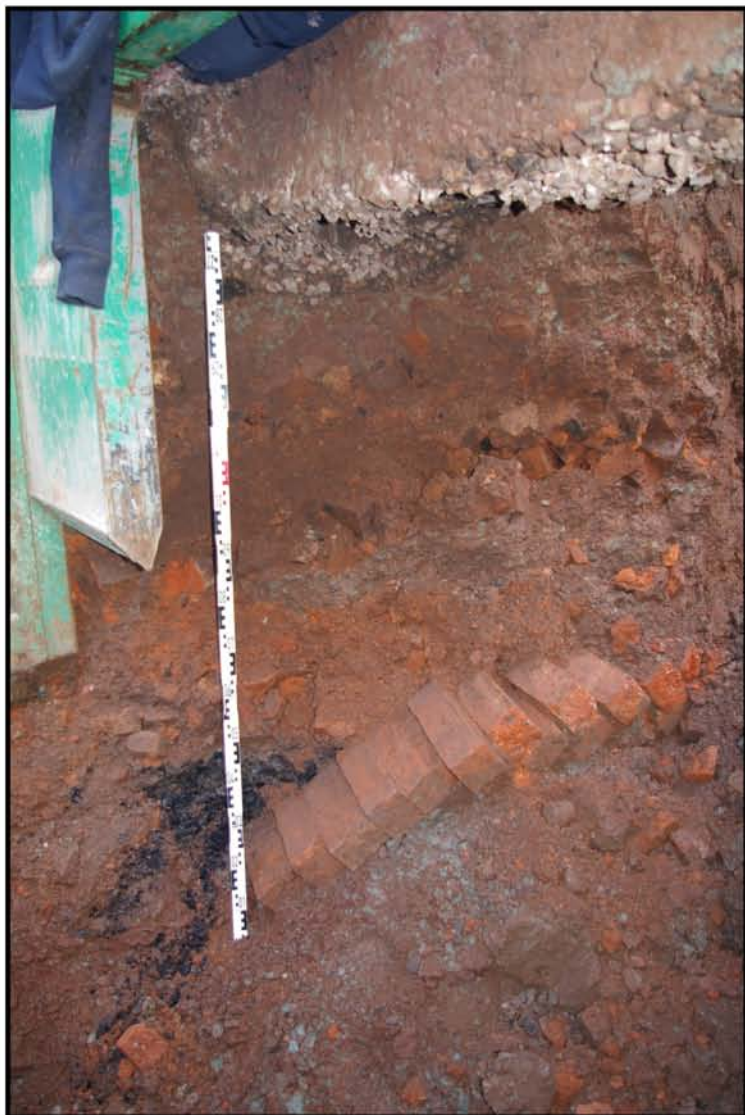
Fig 9: Contexts 023, 024, 017, 018, 019, 020, and 021

In addition, evidence seen on the site itself would also point towards the possibility of brick production on the site, with brick 5 having been found in a gently curving pile (unmortared) on top of a layer of grey clay, believed to be the natural subsoil. It is possible that this pile was the remains of a stockpile of bricks produced on site. Once the site was turned over to landfill, these bricks were buried in the topsoil, along with other rubbish. Unlike the misfired pottery present within the assemblage, it is unlikely that bulky material such as kiln structure and bricks would have been transported any distance for disposal.

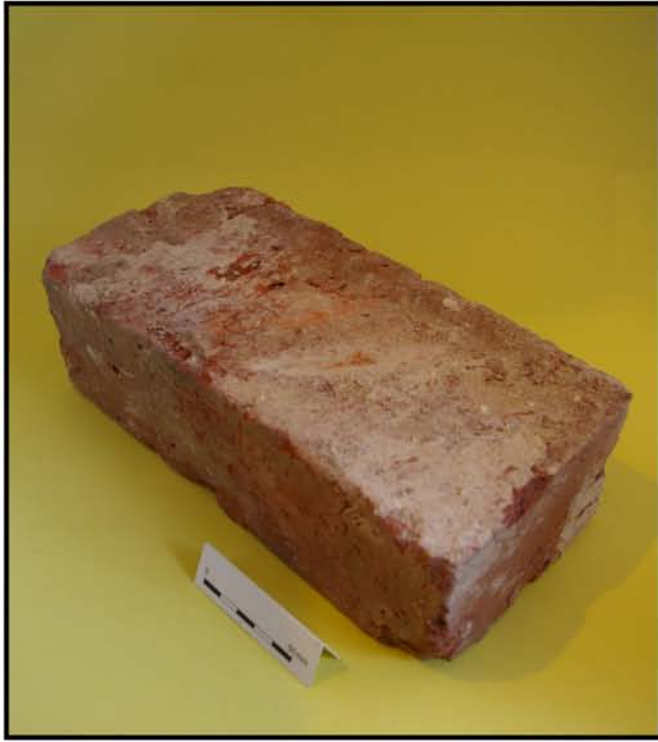
Fig 11: Brick 2

Brick 2 (unstratified; Fig 11)

Dimensions: 9¼ x 4½ x 3 inches

Description: Well-made of red fabric containing subangular, pink argillaceous inclusions (?mudstone). No frog. Fragments of mortar on all surfaces, indicating use in a structure.

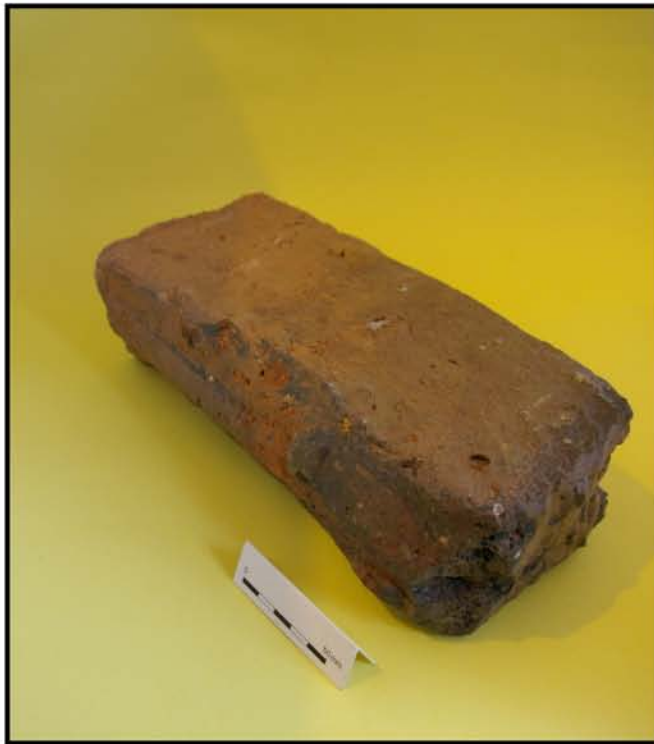
Fig 12: Brick 3

Brick 3 (unstratified; Fig 12)

Dimensions: 9¼ x 4 x 2¾ inches

Description: Appears to be of the same fabric as Brick 1 above. However this example is slightly smaller in overall size and notable due to it having been subjected to extreme heat which has caused vitrification of the brick at one end and distortion along one edge. This heat has also caused the majority of the fabric to turn grey in colour.

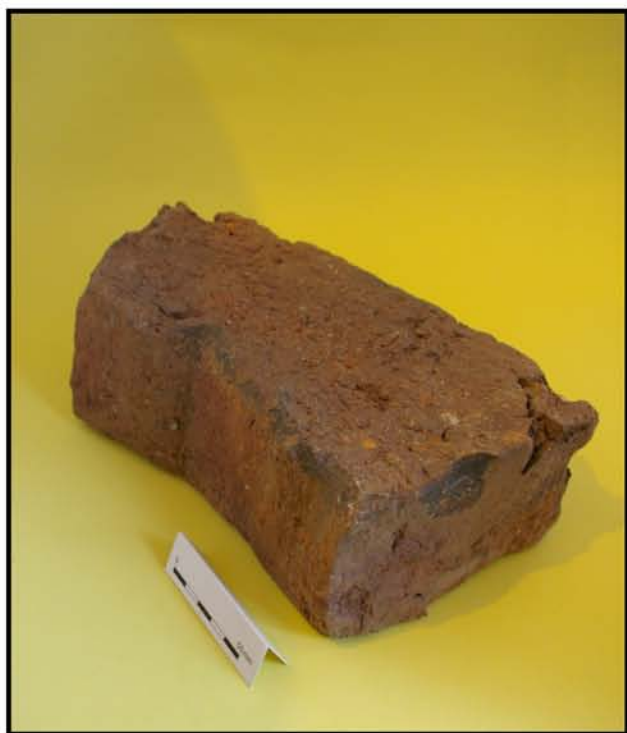
Fig 13: Brick 4

Brick 4 (unstratified; Fig 13)

Dimensions: 9 x 4 x 2¾ inches

Description: Bears close resemblance to Brick 2, being a dark grey/black colour and completely mishapen and distorted due to exposure to extreme heat.

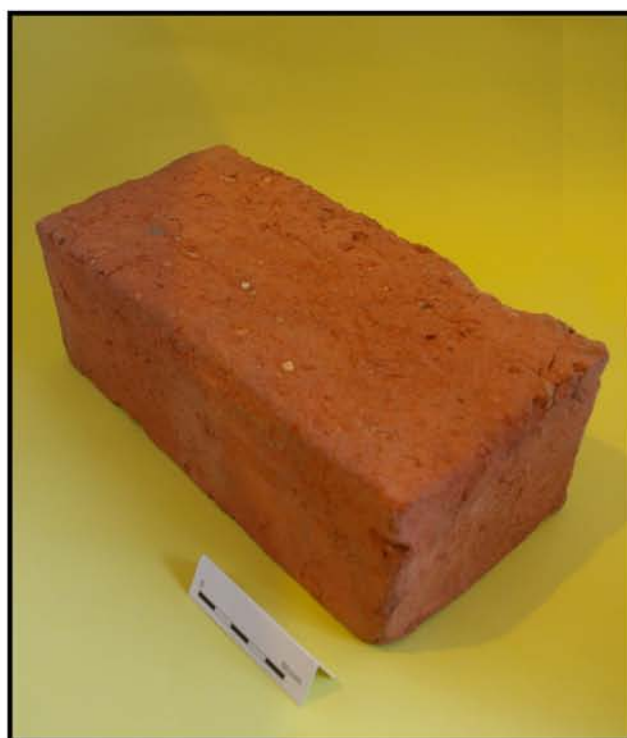
Fig 14: Brick 5

Brick 5 (context 020; Fig 14)

Dimensions: 9¼ x 4½ x 3½ inches

Description: Of same fabric and of similar appearance to Brick 1 with the same well-made body, regular surfaces and no frog.
